A Guide to Mercury Assessment and Elimination in HealthCare Facilities

DEPARTMENT OF HEALTH SERVICES

Diana M. Bontá, R.N. Dr.P.H., Director
DEPARTMENT OF HEALTH SERVICES
September 2000

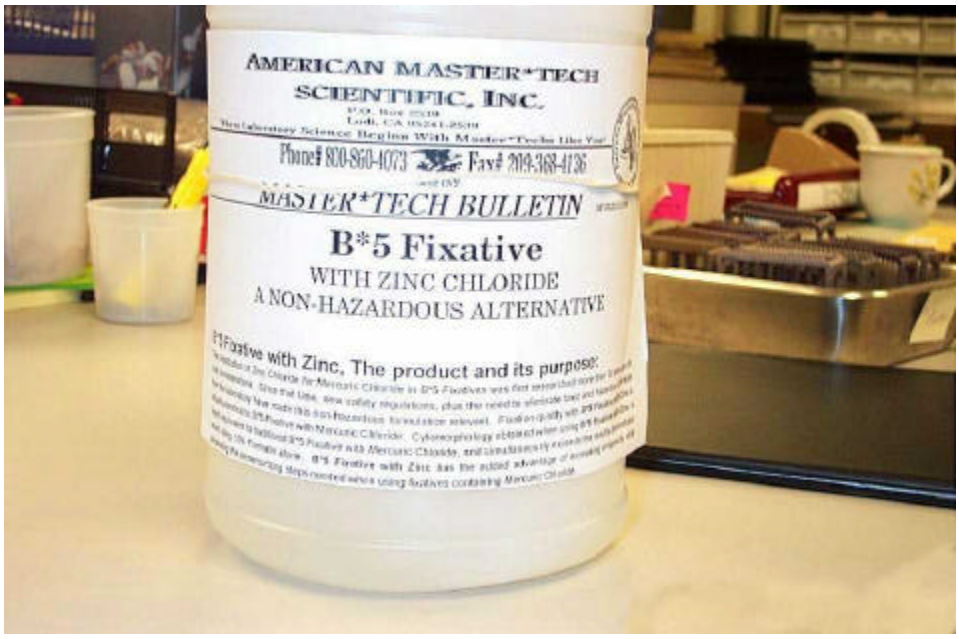
One of the compounds widely used in laboratories is B-5 fixative. This mercury-containing fixative has been used in histology to aid in identification of certain cell types. The tissue would be placed in a container with the B-5 fixative and left until the solution had penetrated the tissue. Then the tissue would be stained and placed onto a slide for microscopic examination. During the rinse process some mercury was discharged into the facility sewer system.

Figure 12 **"B-5" Fixative previously containing mercuric chloride has been replaced with zinc chloride as noted on the label. (Pollution Prevention Project Photograph)**

Several brands of B-5 fixative have been developed using zinc chloride instead of mercury. Laboratory suppliers should be able to provide a listing of possible substitute brands.

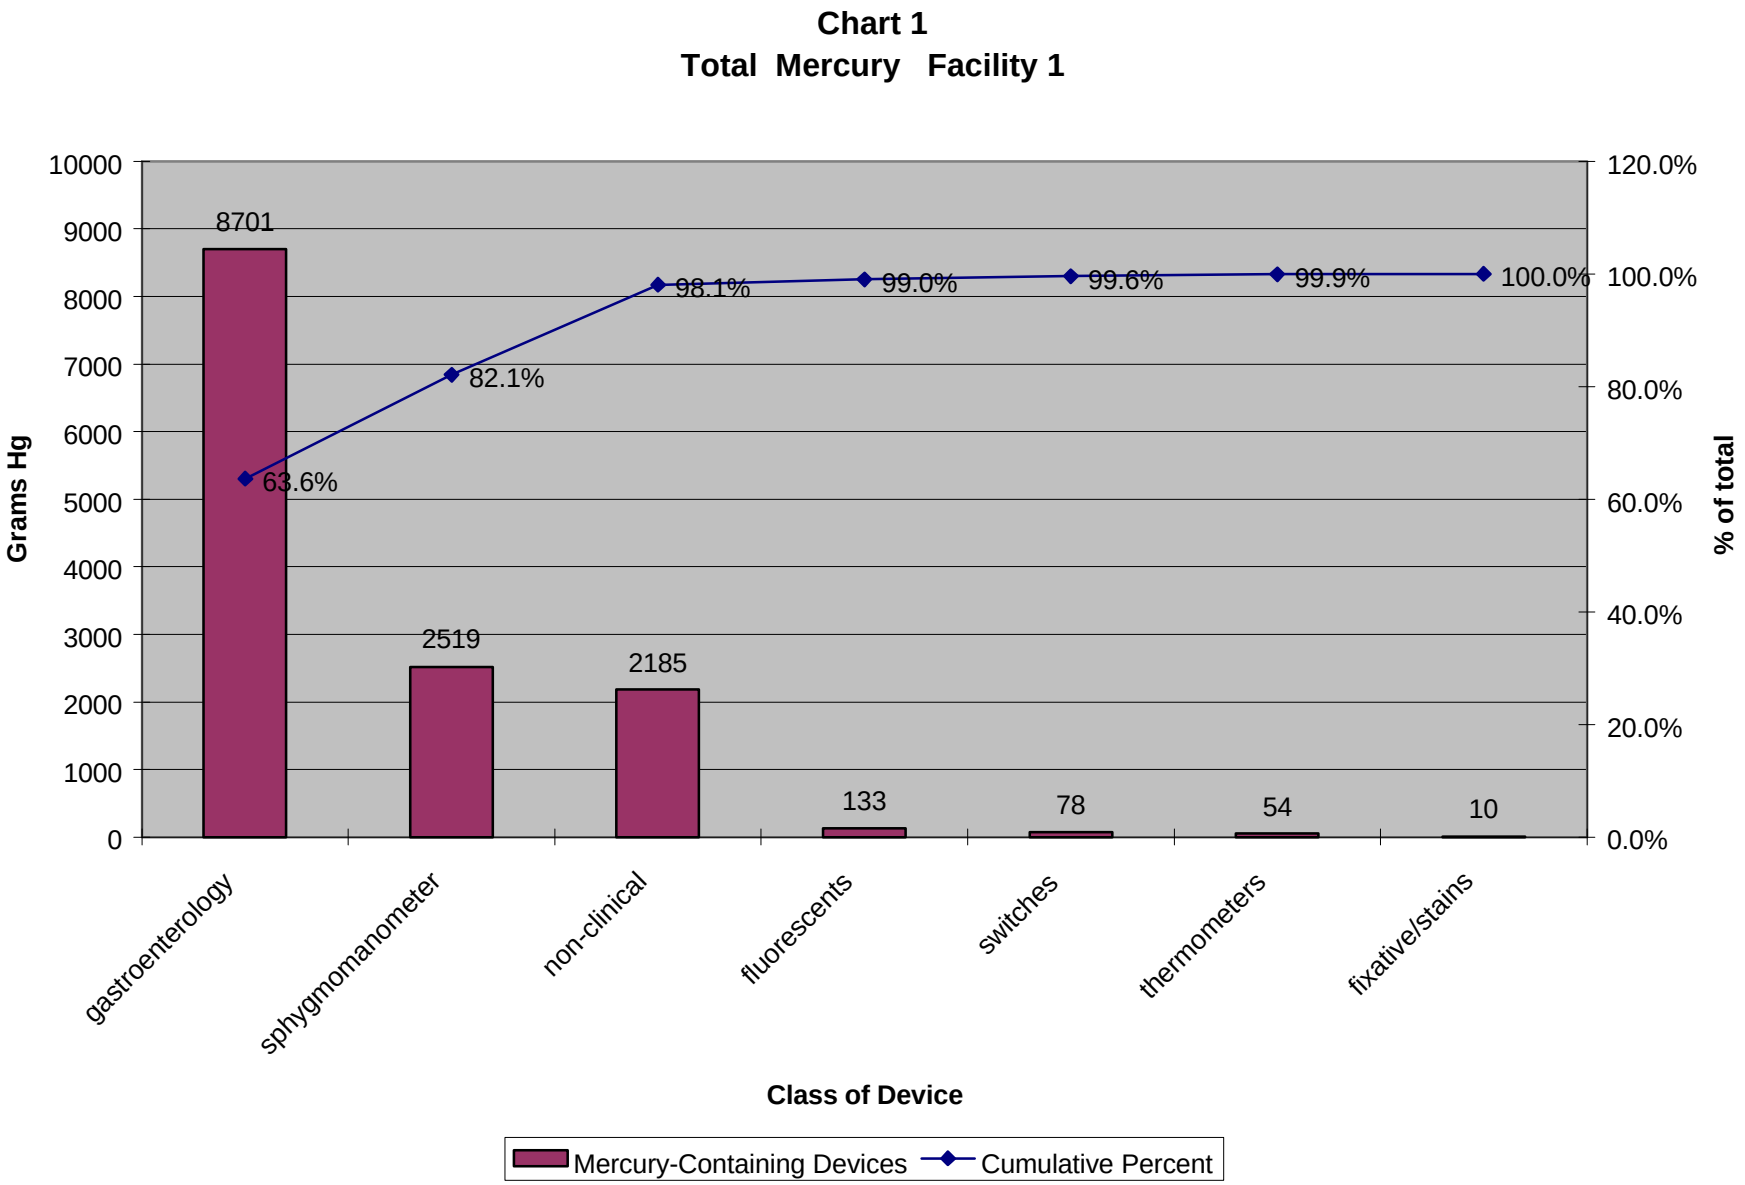
CHART 1. Total mercury (in descending quantity), by class of device or use, plotted vs. cumulative percentage. (Pareto Chart)

TABLE 1. Mercury assessment data. Facility 1.

The mercury sources found at Facility 1 are entered below in the same order as they are shown in Chart 1. As can be seen from the cumulative percent plot on that chart, replacement with non mercury-containing items for the first three classes of devices shown as: (GI Devices, Sphygmomanometers, and the "non-clinical" class (barometer and bulk mercury) will result in a greater than 99 percent reduction of the mercury inventoried, at Facility 1.

- **Bougies.** Facility 1 has already earmarked mercury bougies for replacement with tungsten gel devices. The mercury bougies should be returned to the manufacturer according to existing protocol when their service date is reached. The cost to replace a set of bougies is approximately $3,000. Because the hospital has already replaced one of its two sets of bougies, the total expense for bougie replacement would be $3,000.

- **Other GI:** Non-mercury substitutes for many other gastroenterologic devices are in place. Blakemore tubes which use a dense rubber end, rather than a mercury-weighted end, are available to replace the four mercury-containing tubes that were inventoried. Their individual cost is $202; total replacement would be $808.

- **Sphygmomanometers:** The survey revealed that Facility 1 had replaced all but about 30 of its mercury sphygmomanometers. Replacement of the remaining sphygmomanometers is expected to continue and should not cost more than $148.50 per unit. The total amount required to implement this portion of the Business Plan would be $4,455. Proprietary exchange agreements are available that will take care of the disposal of removed mercury units and recycling of the mercury. Facility 1 should explore the feasibility of using such an arrangement for replacing their mercury sphygmomanometers.

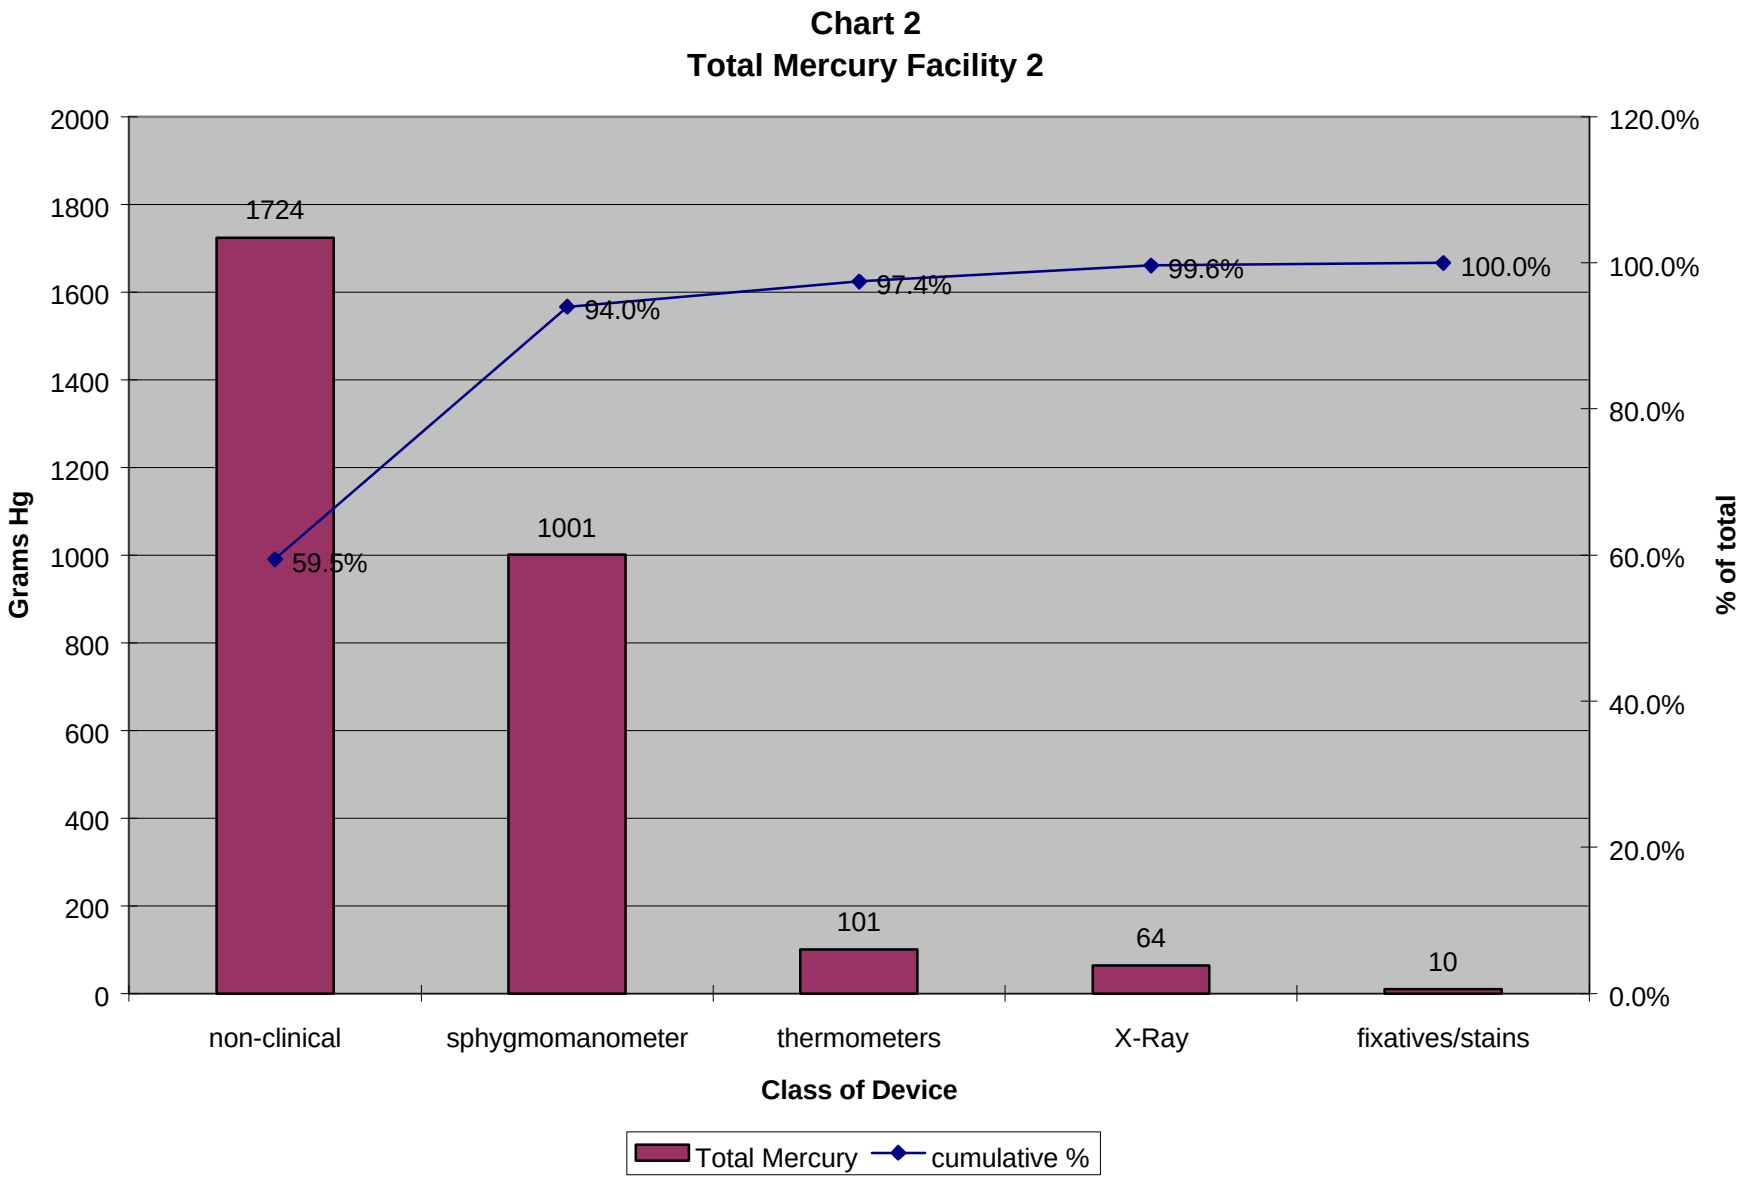
CHART 2. Total mercury (in descending quantity), by class of device or use, plotted vs. cumulative percentage. (Pareto Chart)

TABLE 2. Mercury assessment data. Facility 2.

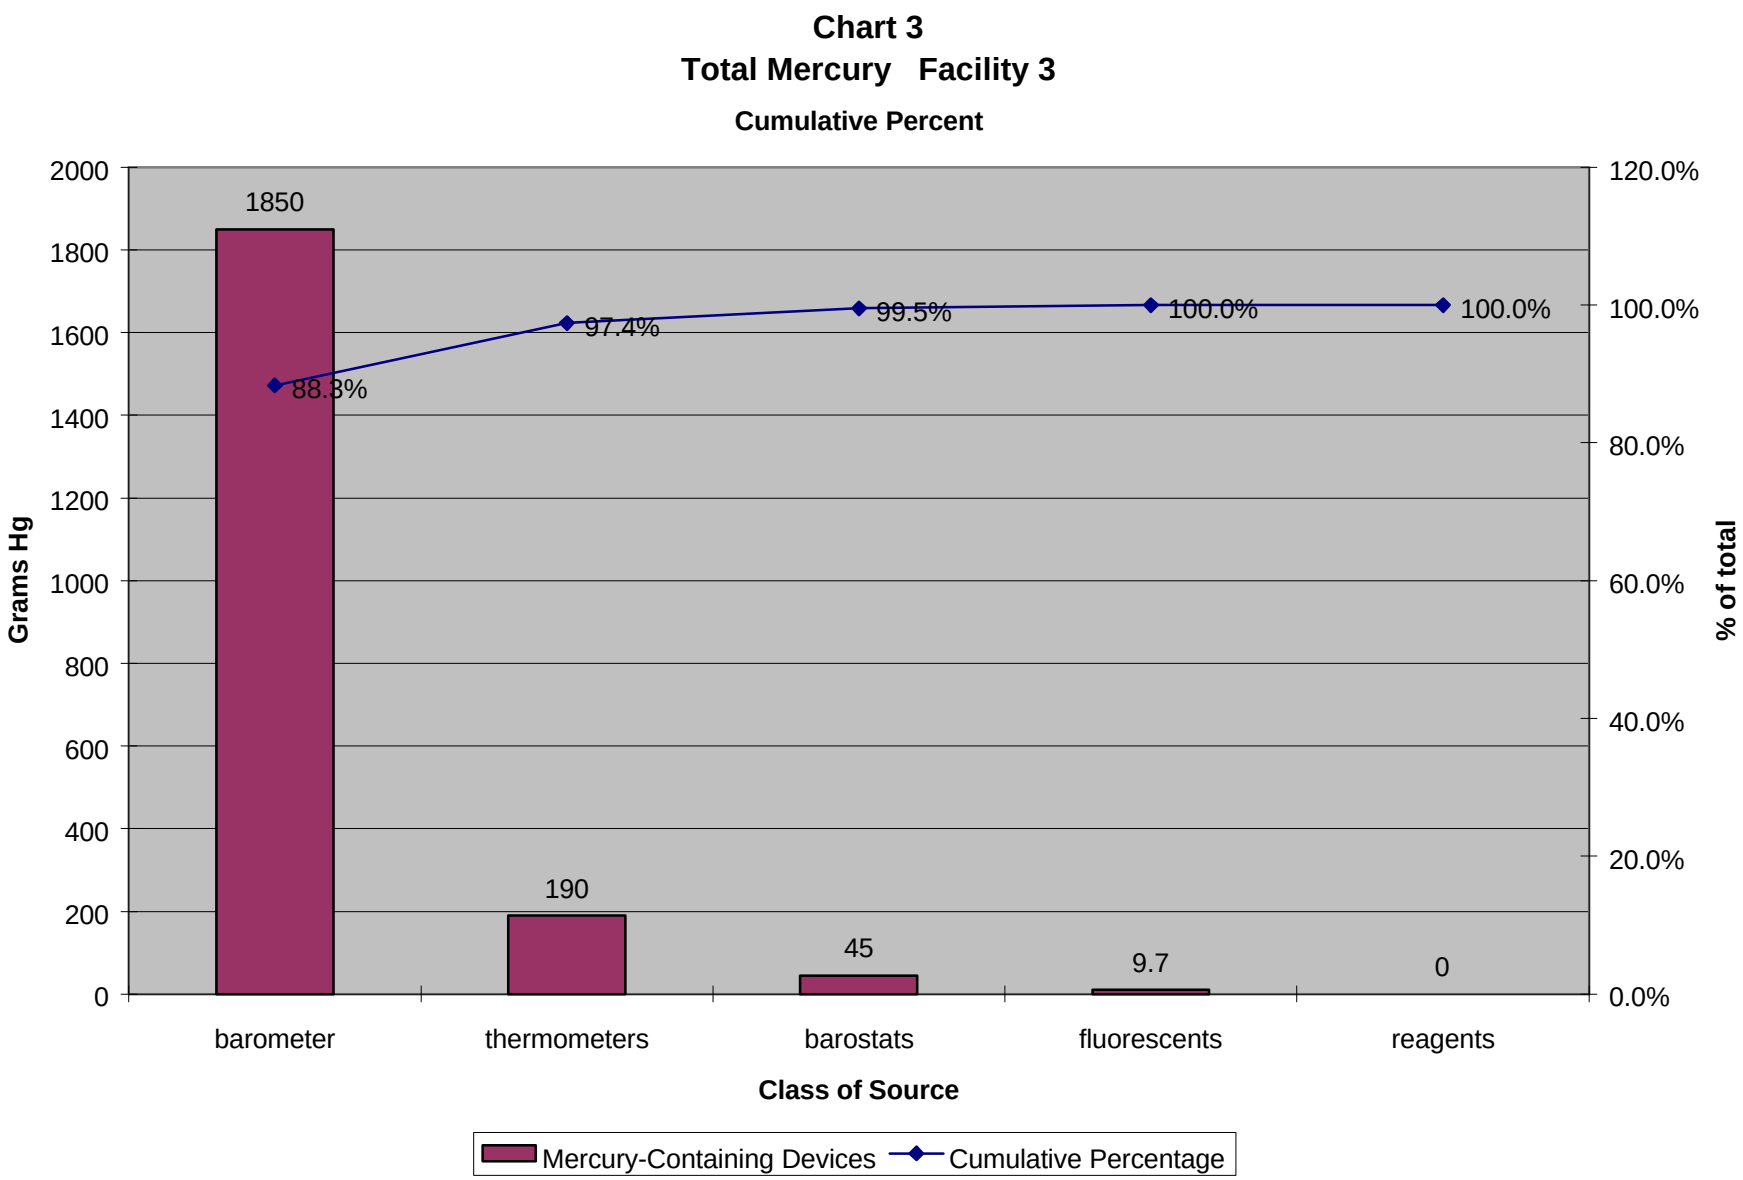
CHART 3. Total mercury (in descending quantity), by class of device or use, plotted vs. cumulative percentage. (Pareto Chart)

TABLE 3. Mercury assessment data for Facility 3.

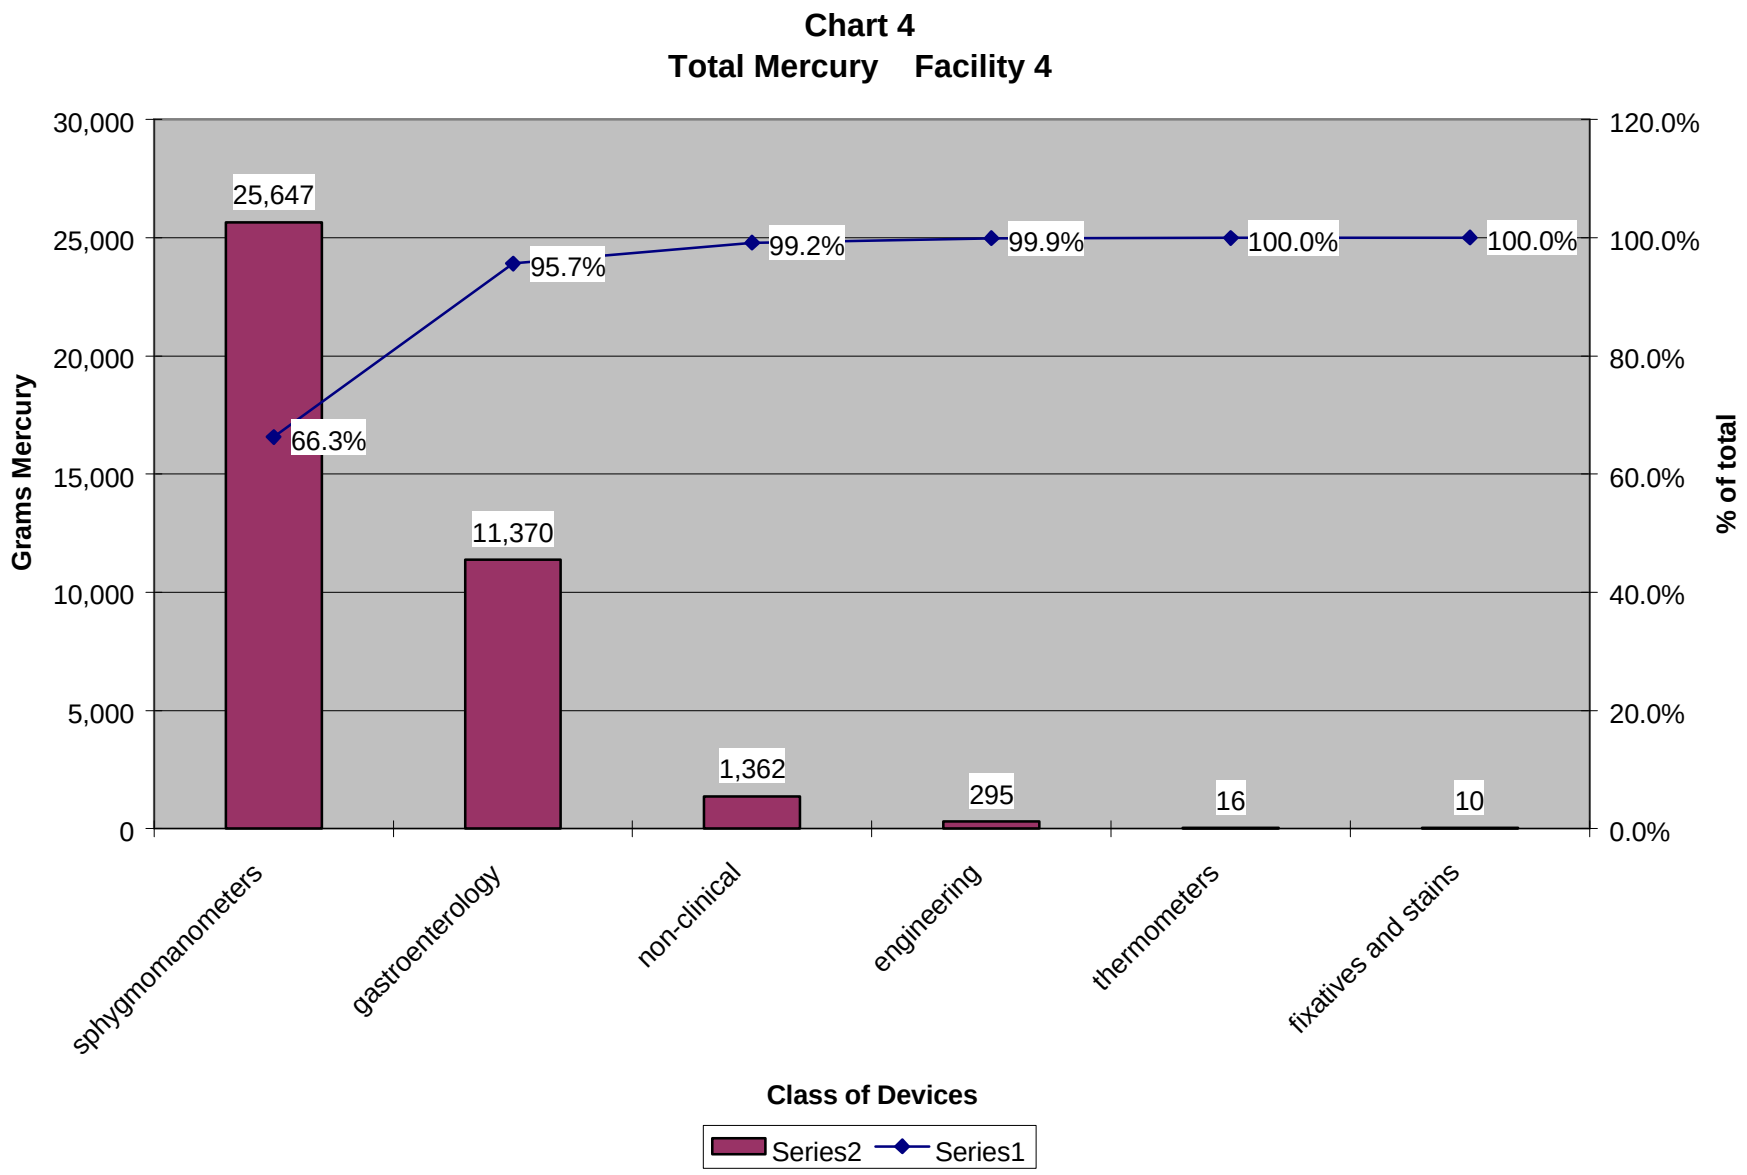
CHART 4. Total mercury (in descending quantity), by class of device or use, plotted vs. cumulative percentage. (Pareto Chart)

TABLE 4. Mercury assessment data for Facility 4.

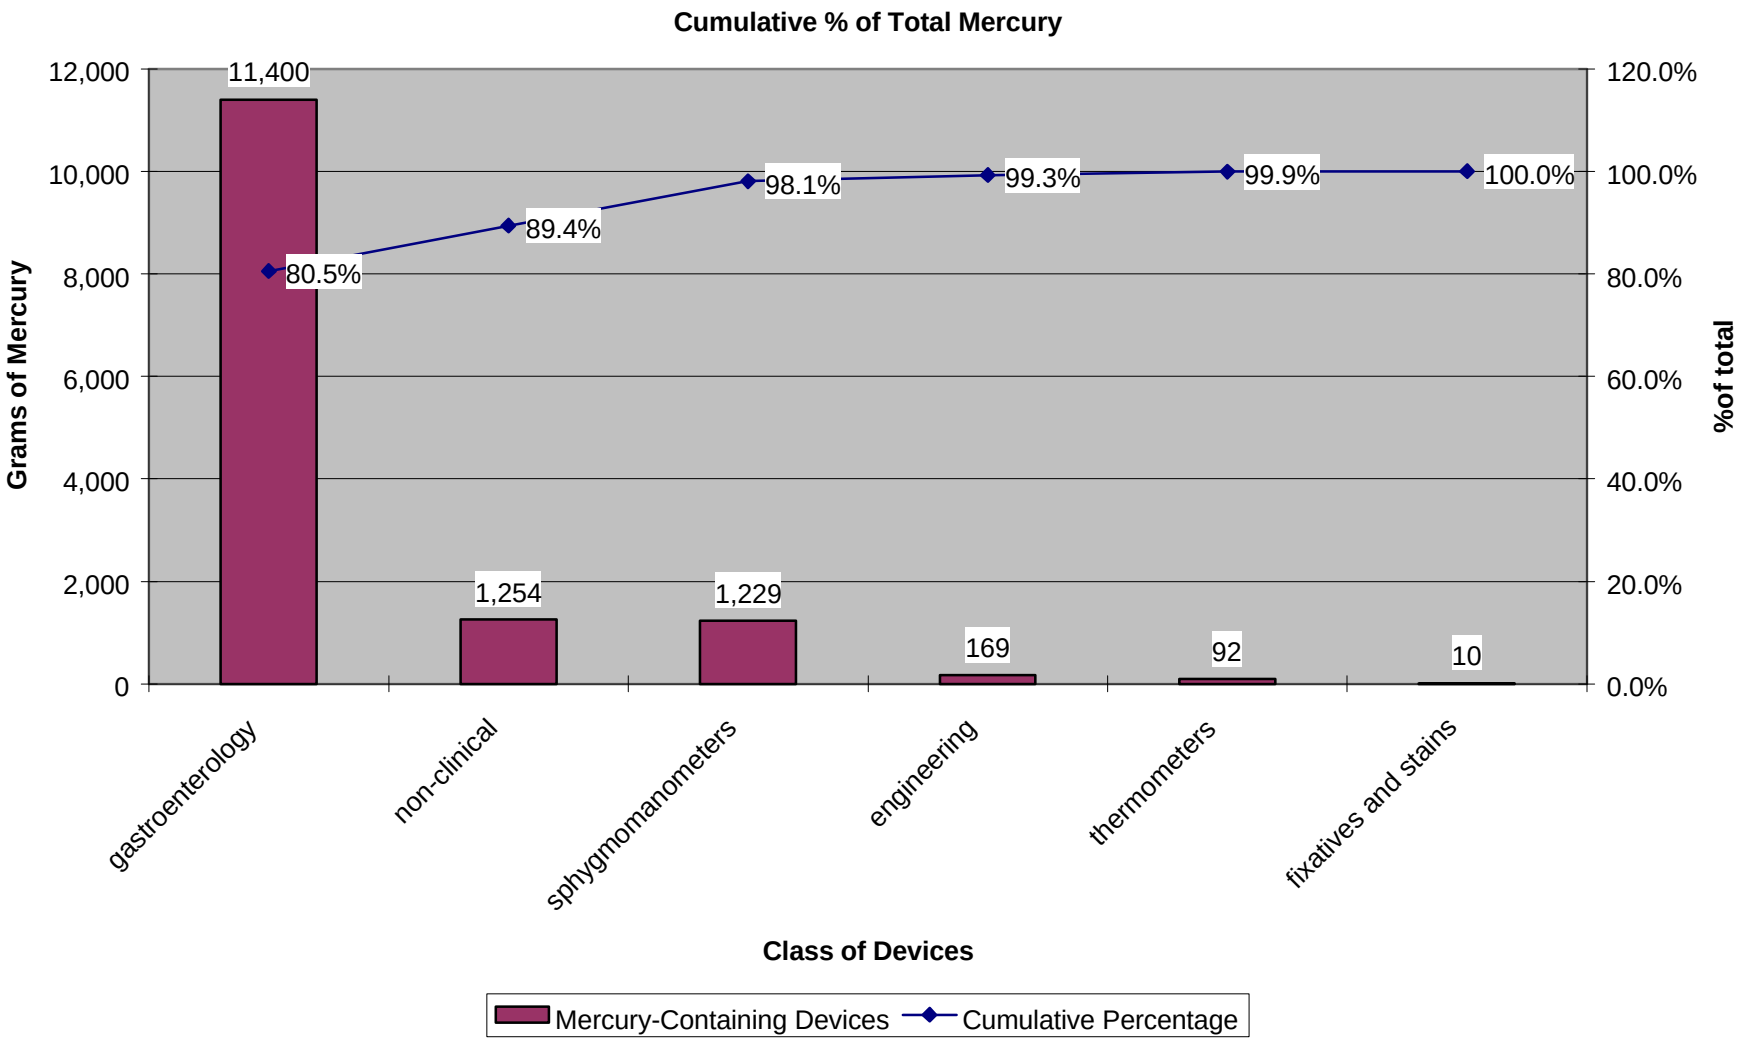
Chart 5
Total Mercury Faciltiy 5

TABLE 5. Mercury assessment data for Facility 5.

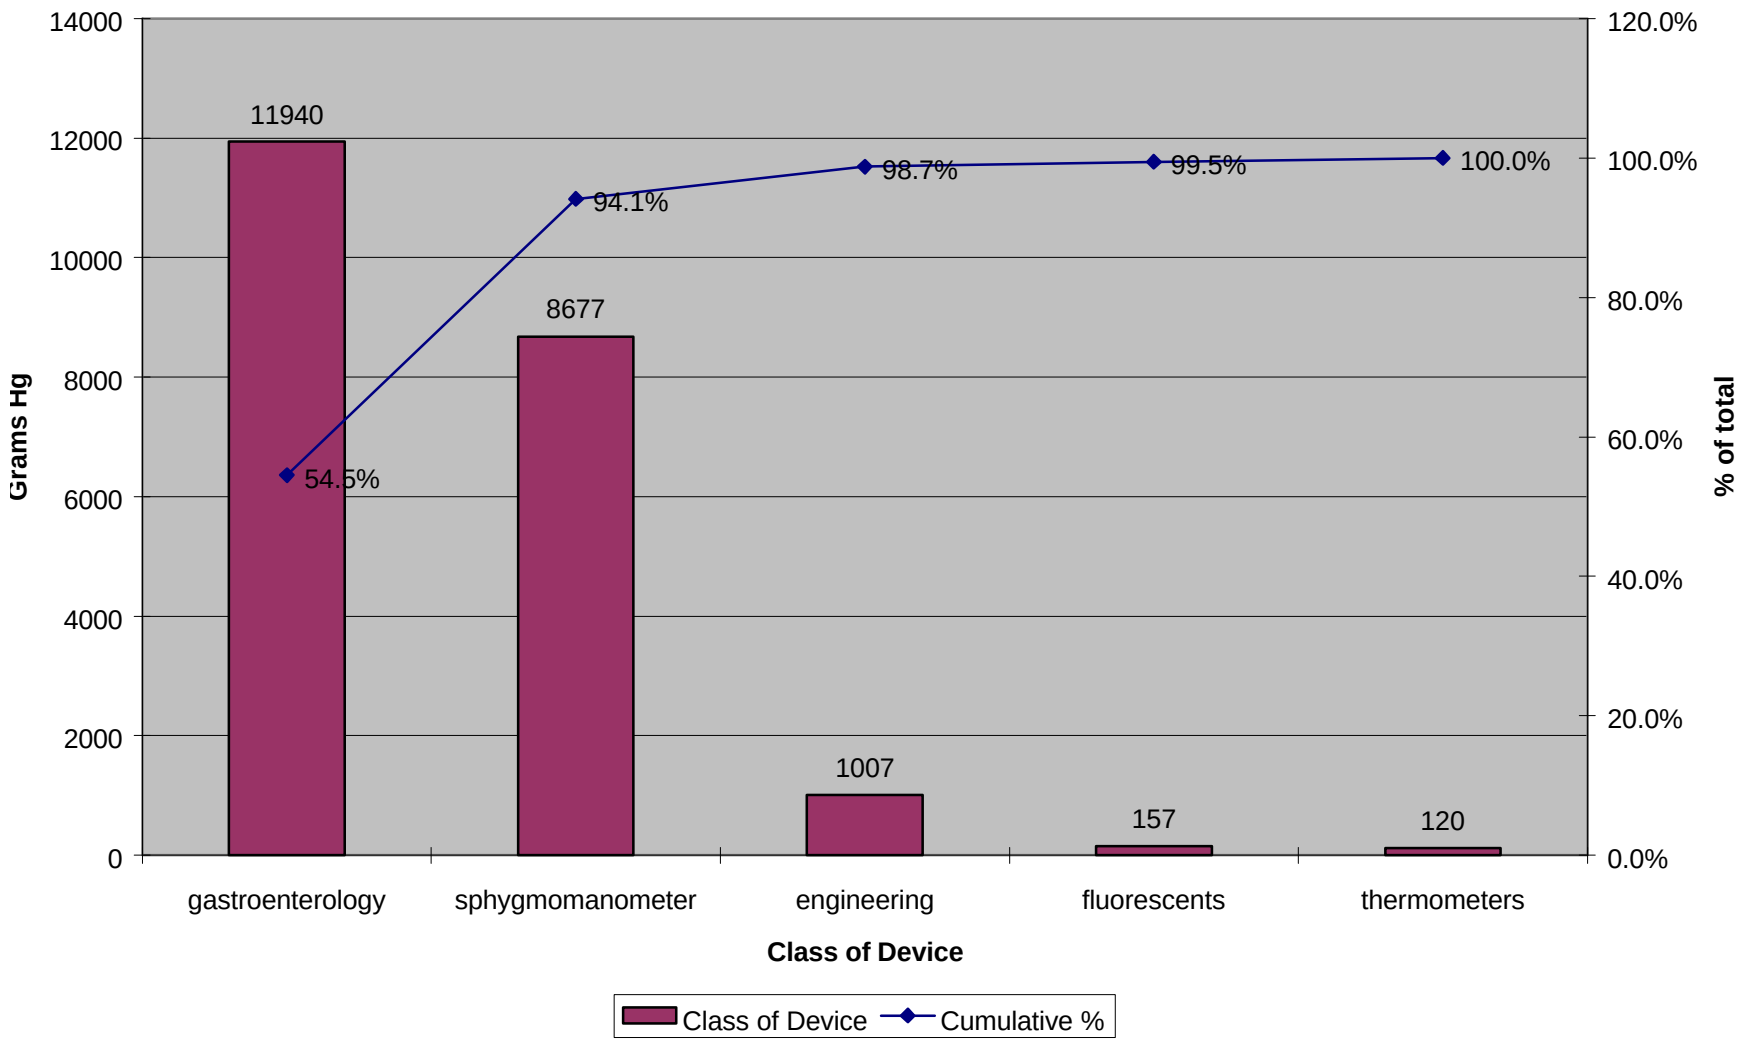
Chart 6
Total Mercury Facility 6

TABLE 6. Mercury assessment data for Facility 6.

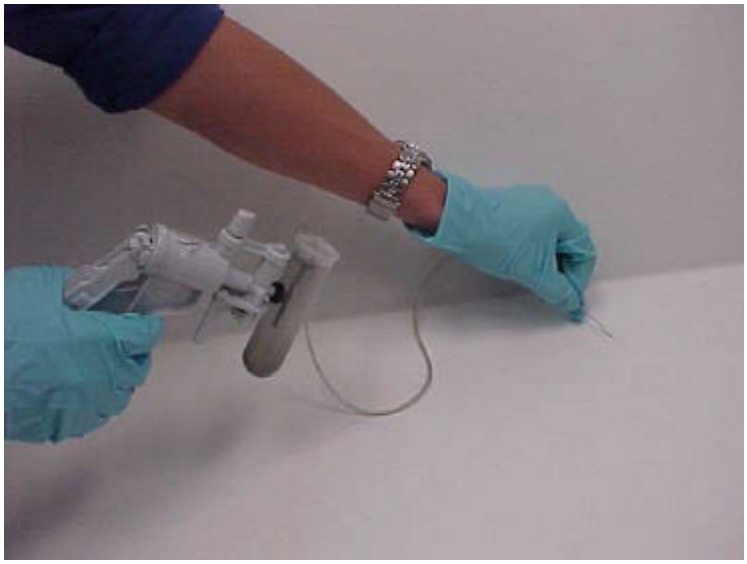
Figure 22 Micro vacuum being used to pick up spilled mercury. (Photo courtesy of UCLA, Office of Environment, Health & Safety)

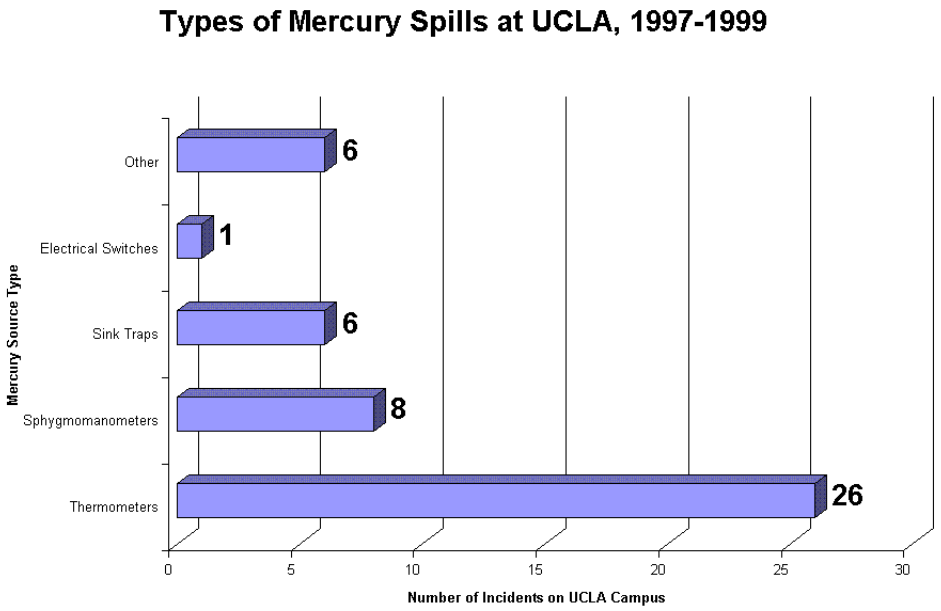
A total of 47 mercury spills were recorded on the UCLA campus from 1997 through 1999. A breakdown of the sources of these spills is presented in Figure 23. As can be seen from the data presented in Figure 23, thermometers accounted for 26 (55.3 percent) of the incidents. Sphygmomanometers were the second most frequent source of mercury spills during the 1997-99 period with eight spills representing 17.0 percent of the total events. Sink traps accounted for six mercury spills, including the CHS event, which represented 12.8 percent of the incidents. It is interesting to note that 42 percent of the hazardous materials incidents responded to by the UCLA Haz Mat Unit involve mercury. The UCLA Haz Mat Unit expended 280.59 hours responding to hazardous waste incidents during the years 1997-99. The personnel costs for the Haz Mat Unit are computed at $100 per hour resulting in a cost of $28,059 for the three year period.

Figure 23 Mercury spills on UCLA campus 1997-99 by source type. (Graph courtesy of UCLA, Office of the Environment, Health & Safety)
